**PROJECT:** Midnite Mine Remediation

**REPORT NO:** 2019-014

## Summary of Work Activities or Events for this reporting period:

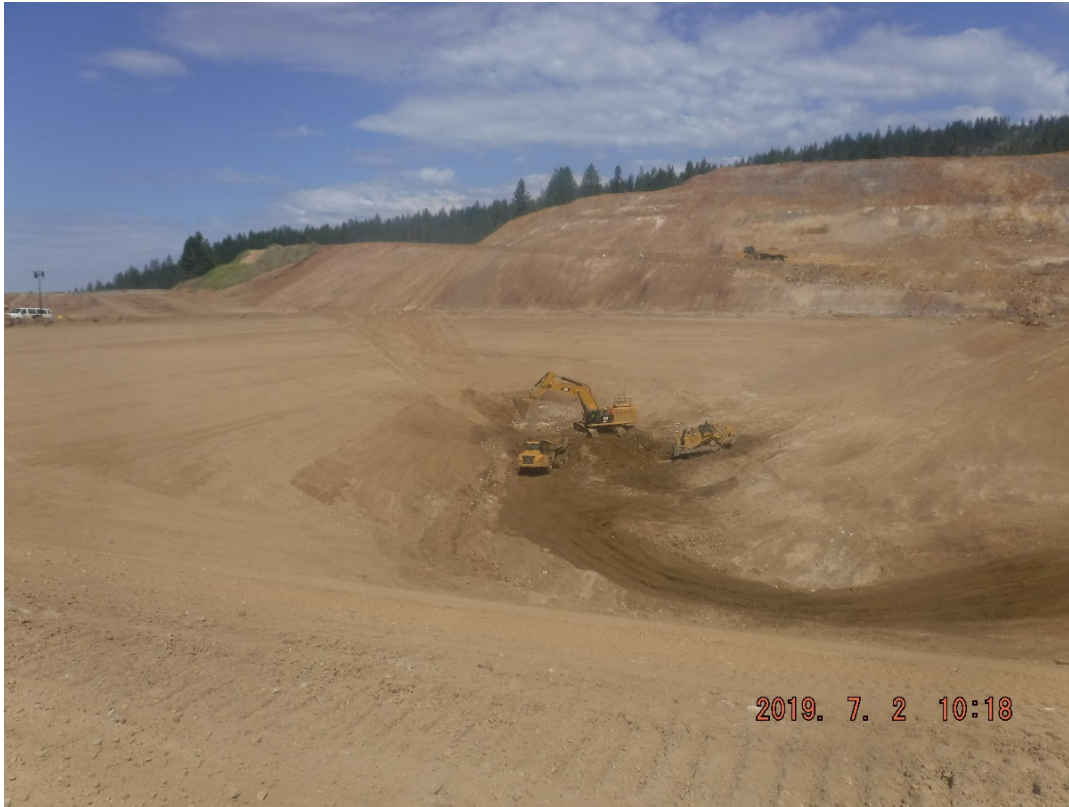
**Figure 1 – 390 excavator loading material from the South Pond excavation.**

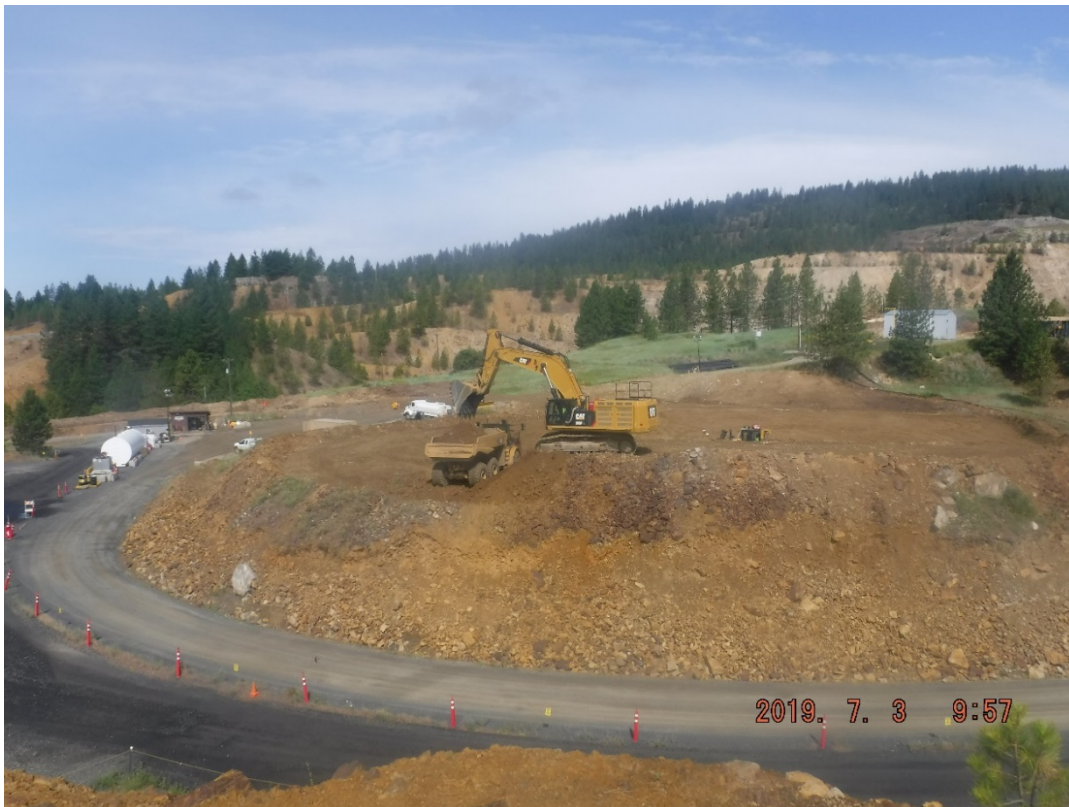
**Figure 2 – 390 excavator loading Stockpile-1 material.**

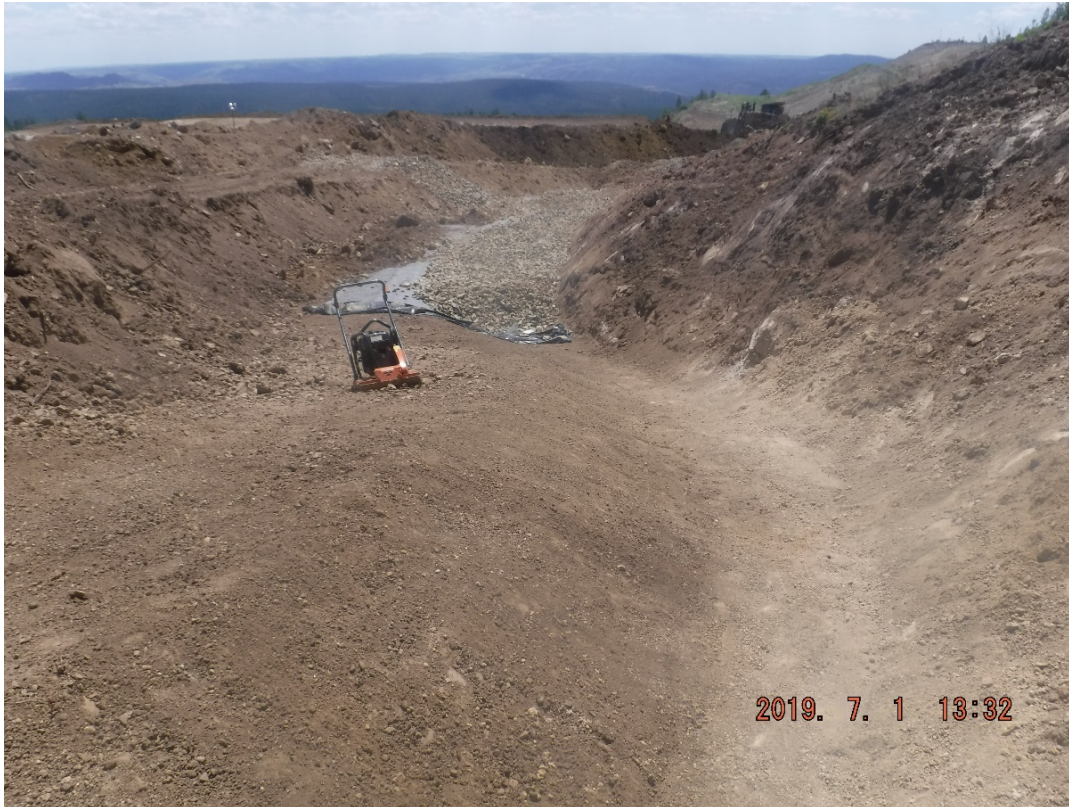
**Figure 3 – Prepared additional IC subgrade for installation of GCL.**

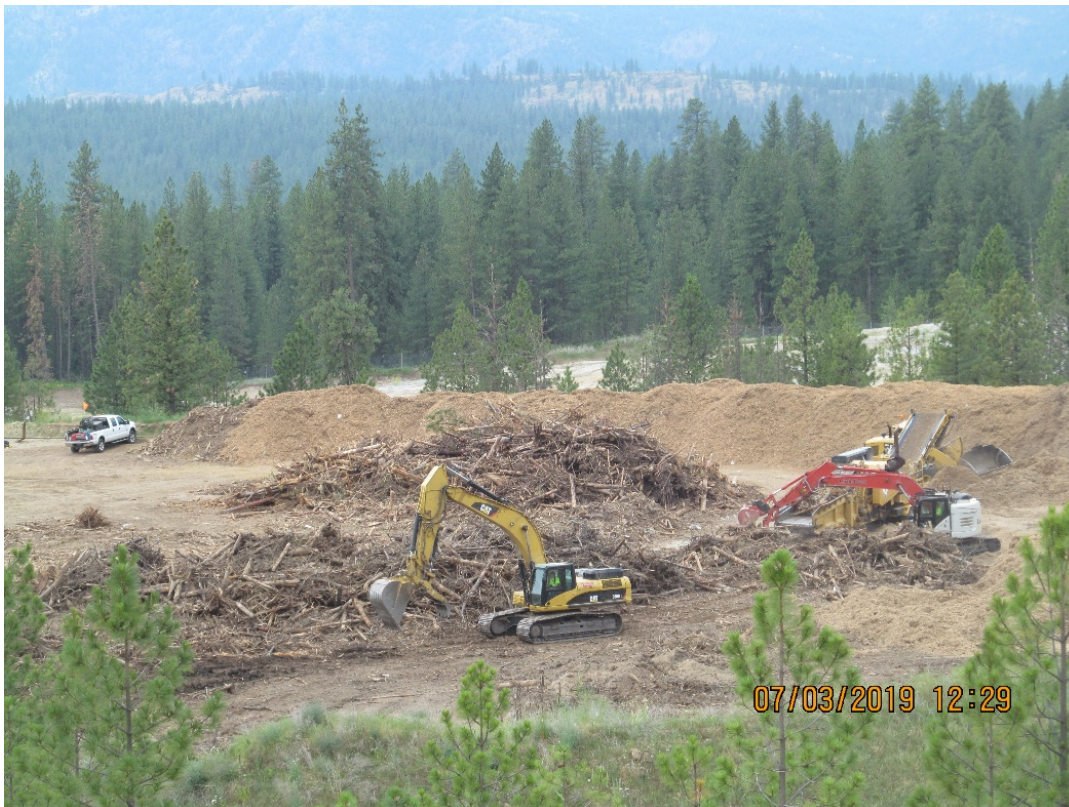
**Figure 4 – Wood Chipping at the TISS, Looking West**
